# REGENT PARK PHASES 4&5

LANDSCAPE SET

REGENT PARK

PHASES 4 & 5

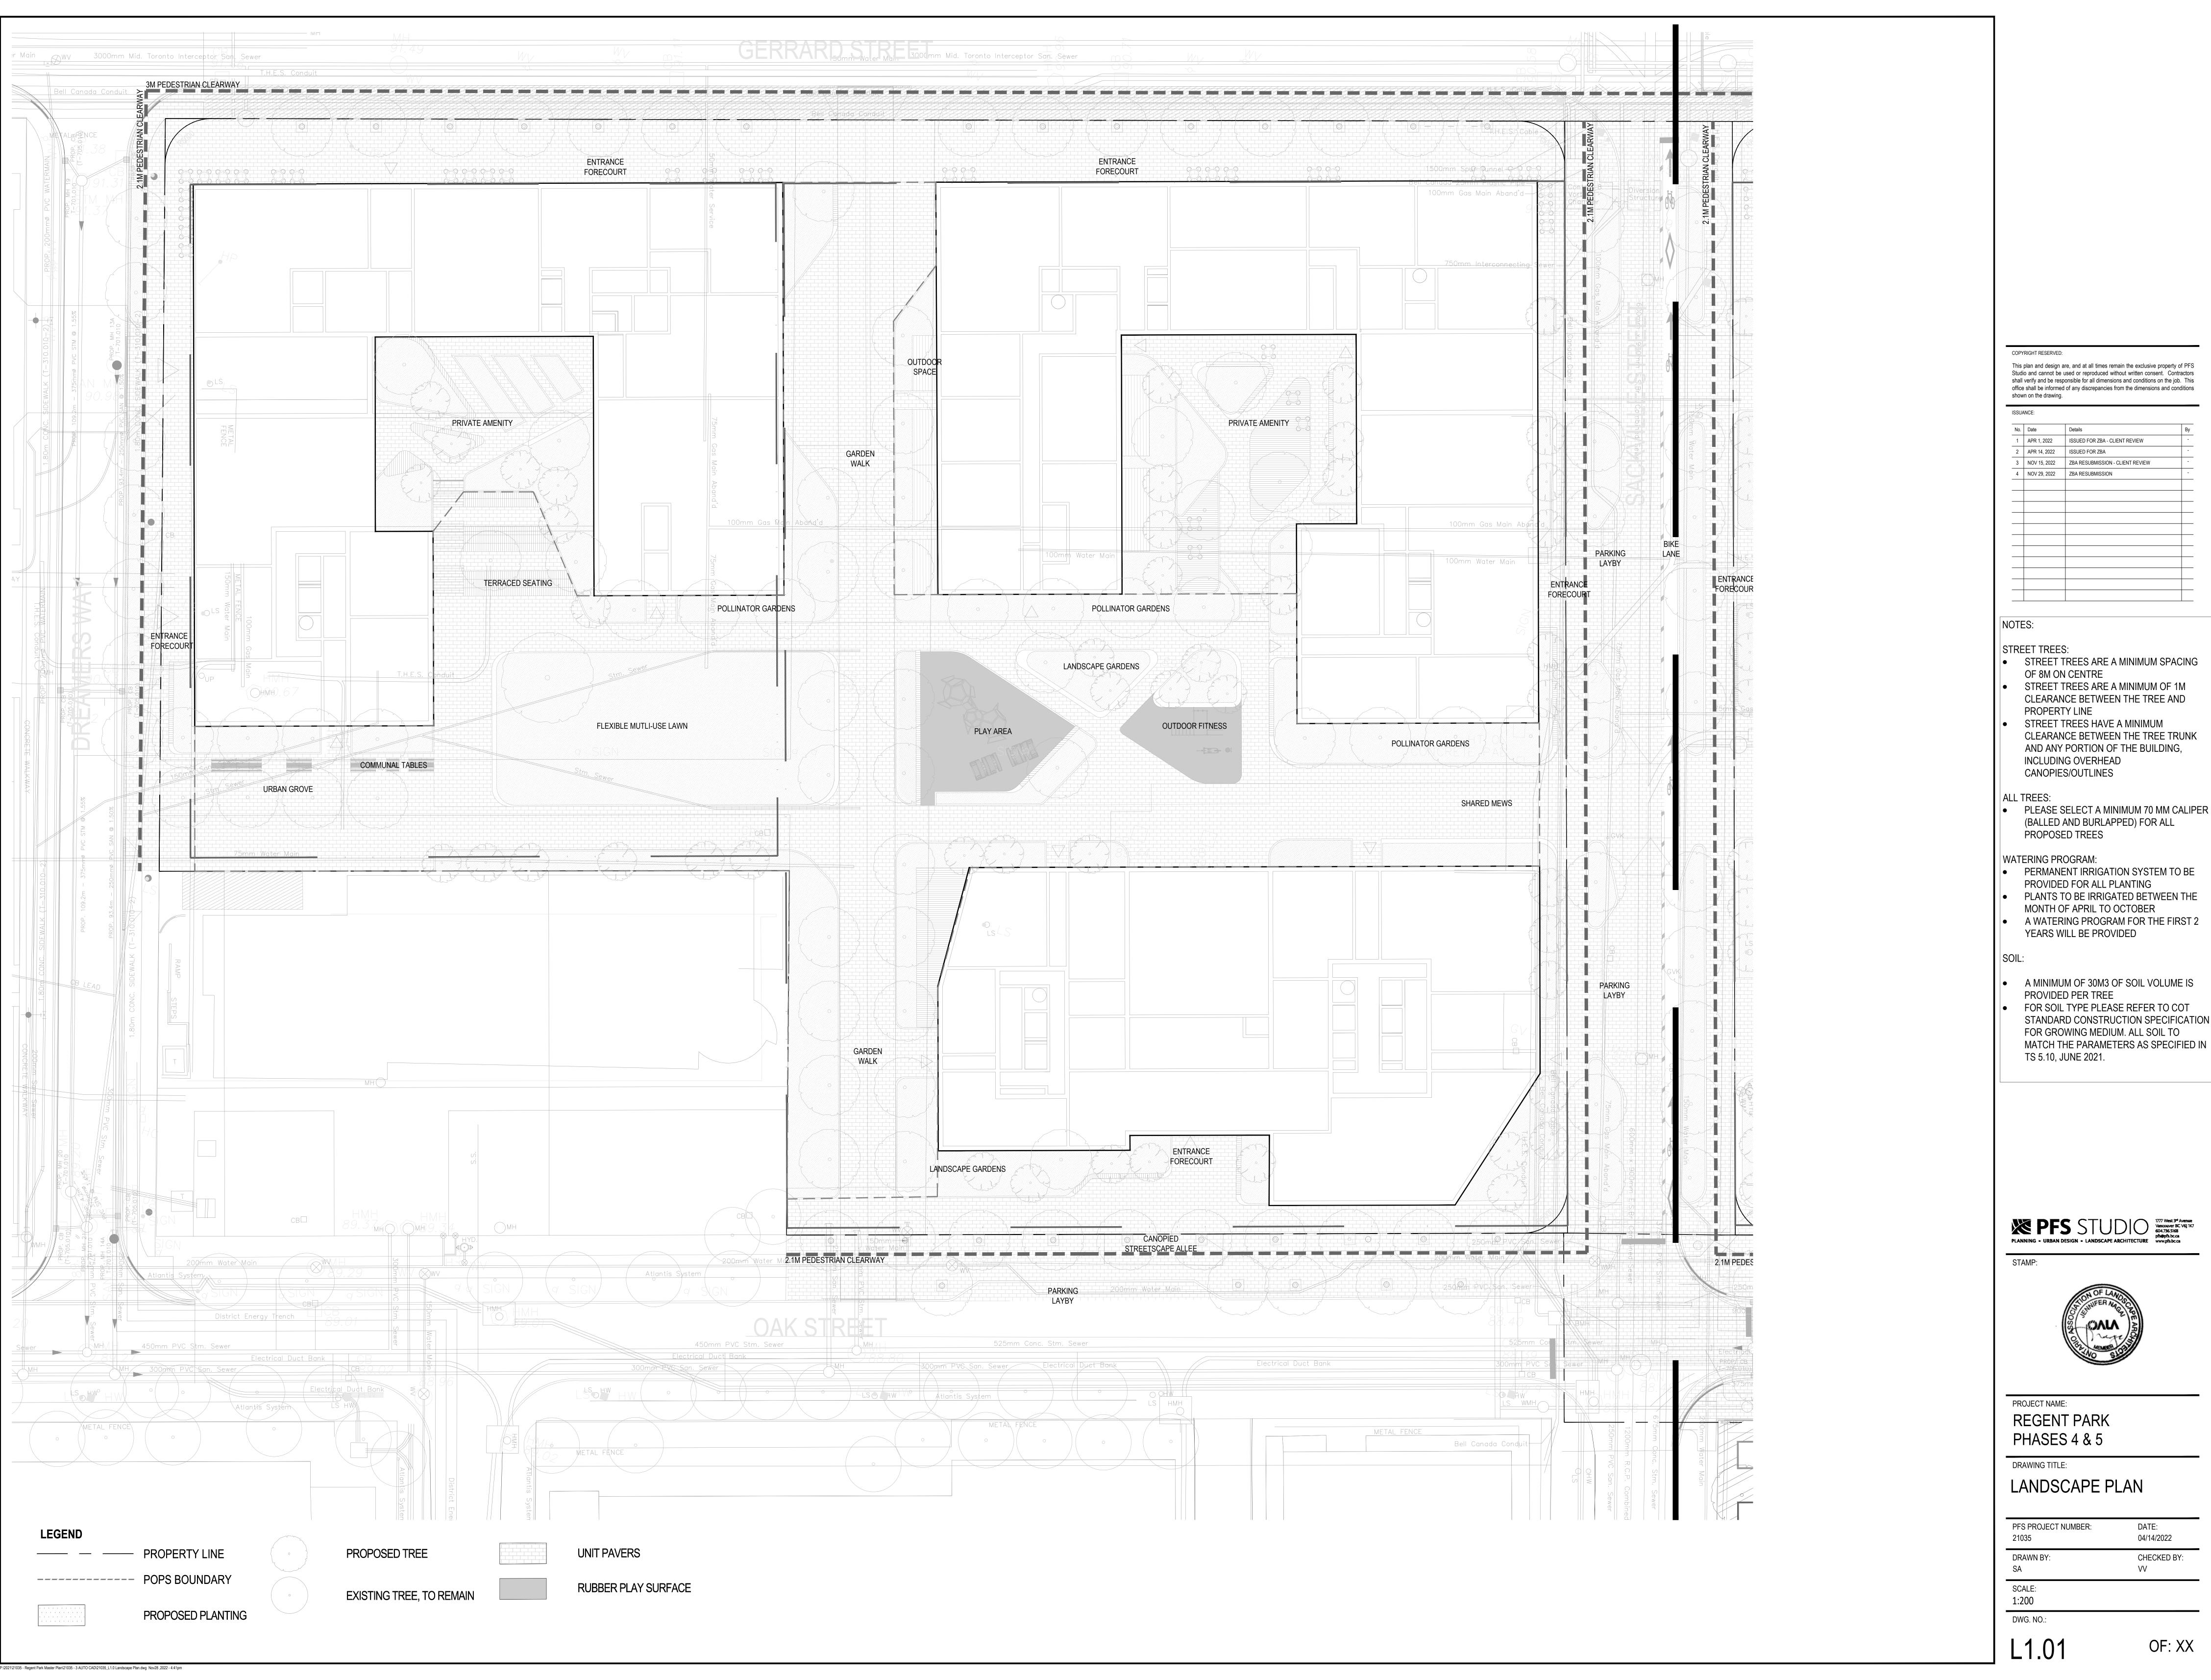
LANDSCAPE PLAN

- STREET TREES ARE A MINIMUM SPACING OF 8M ON CENTRE • STREET TREES ARE A MINIMUM OF 1M
- CLEARANCE BETWEEN THE TREE AND PROPERTY LINE STREET TREES HAVE A MINIMUM
- CLEARANCE BETWEEN THE TREE TRUNK AND ANY PORTION OF THE BUILDING, INCLUDING OVERHEAD CANOPIES/OUTLINES

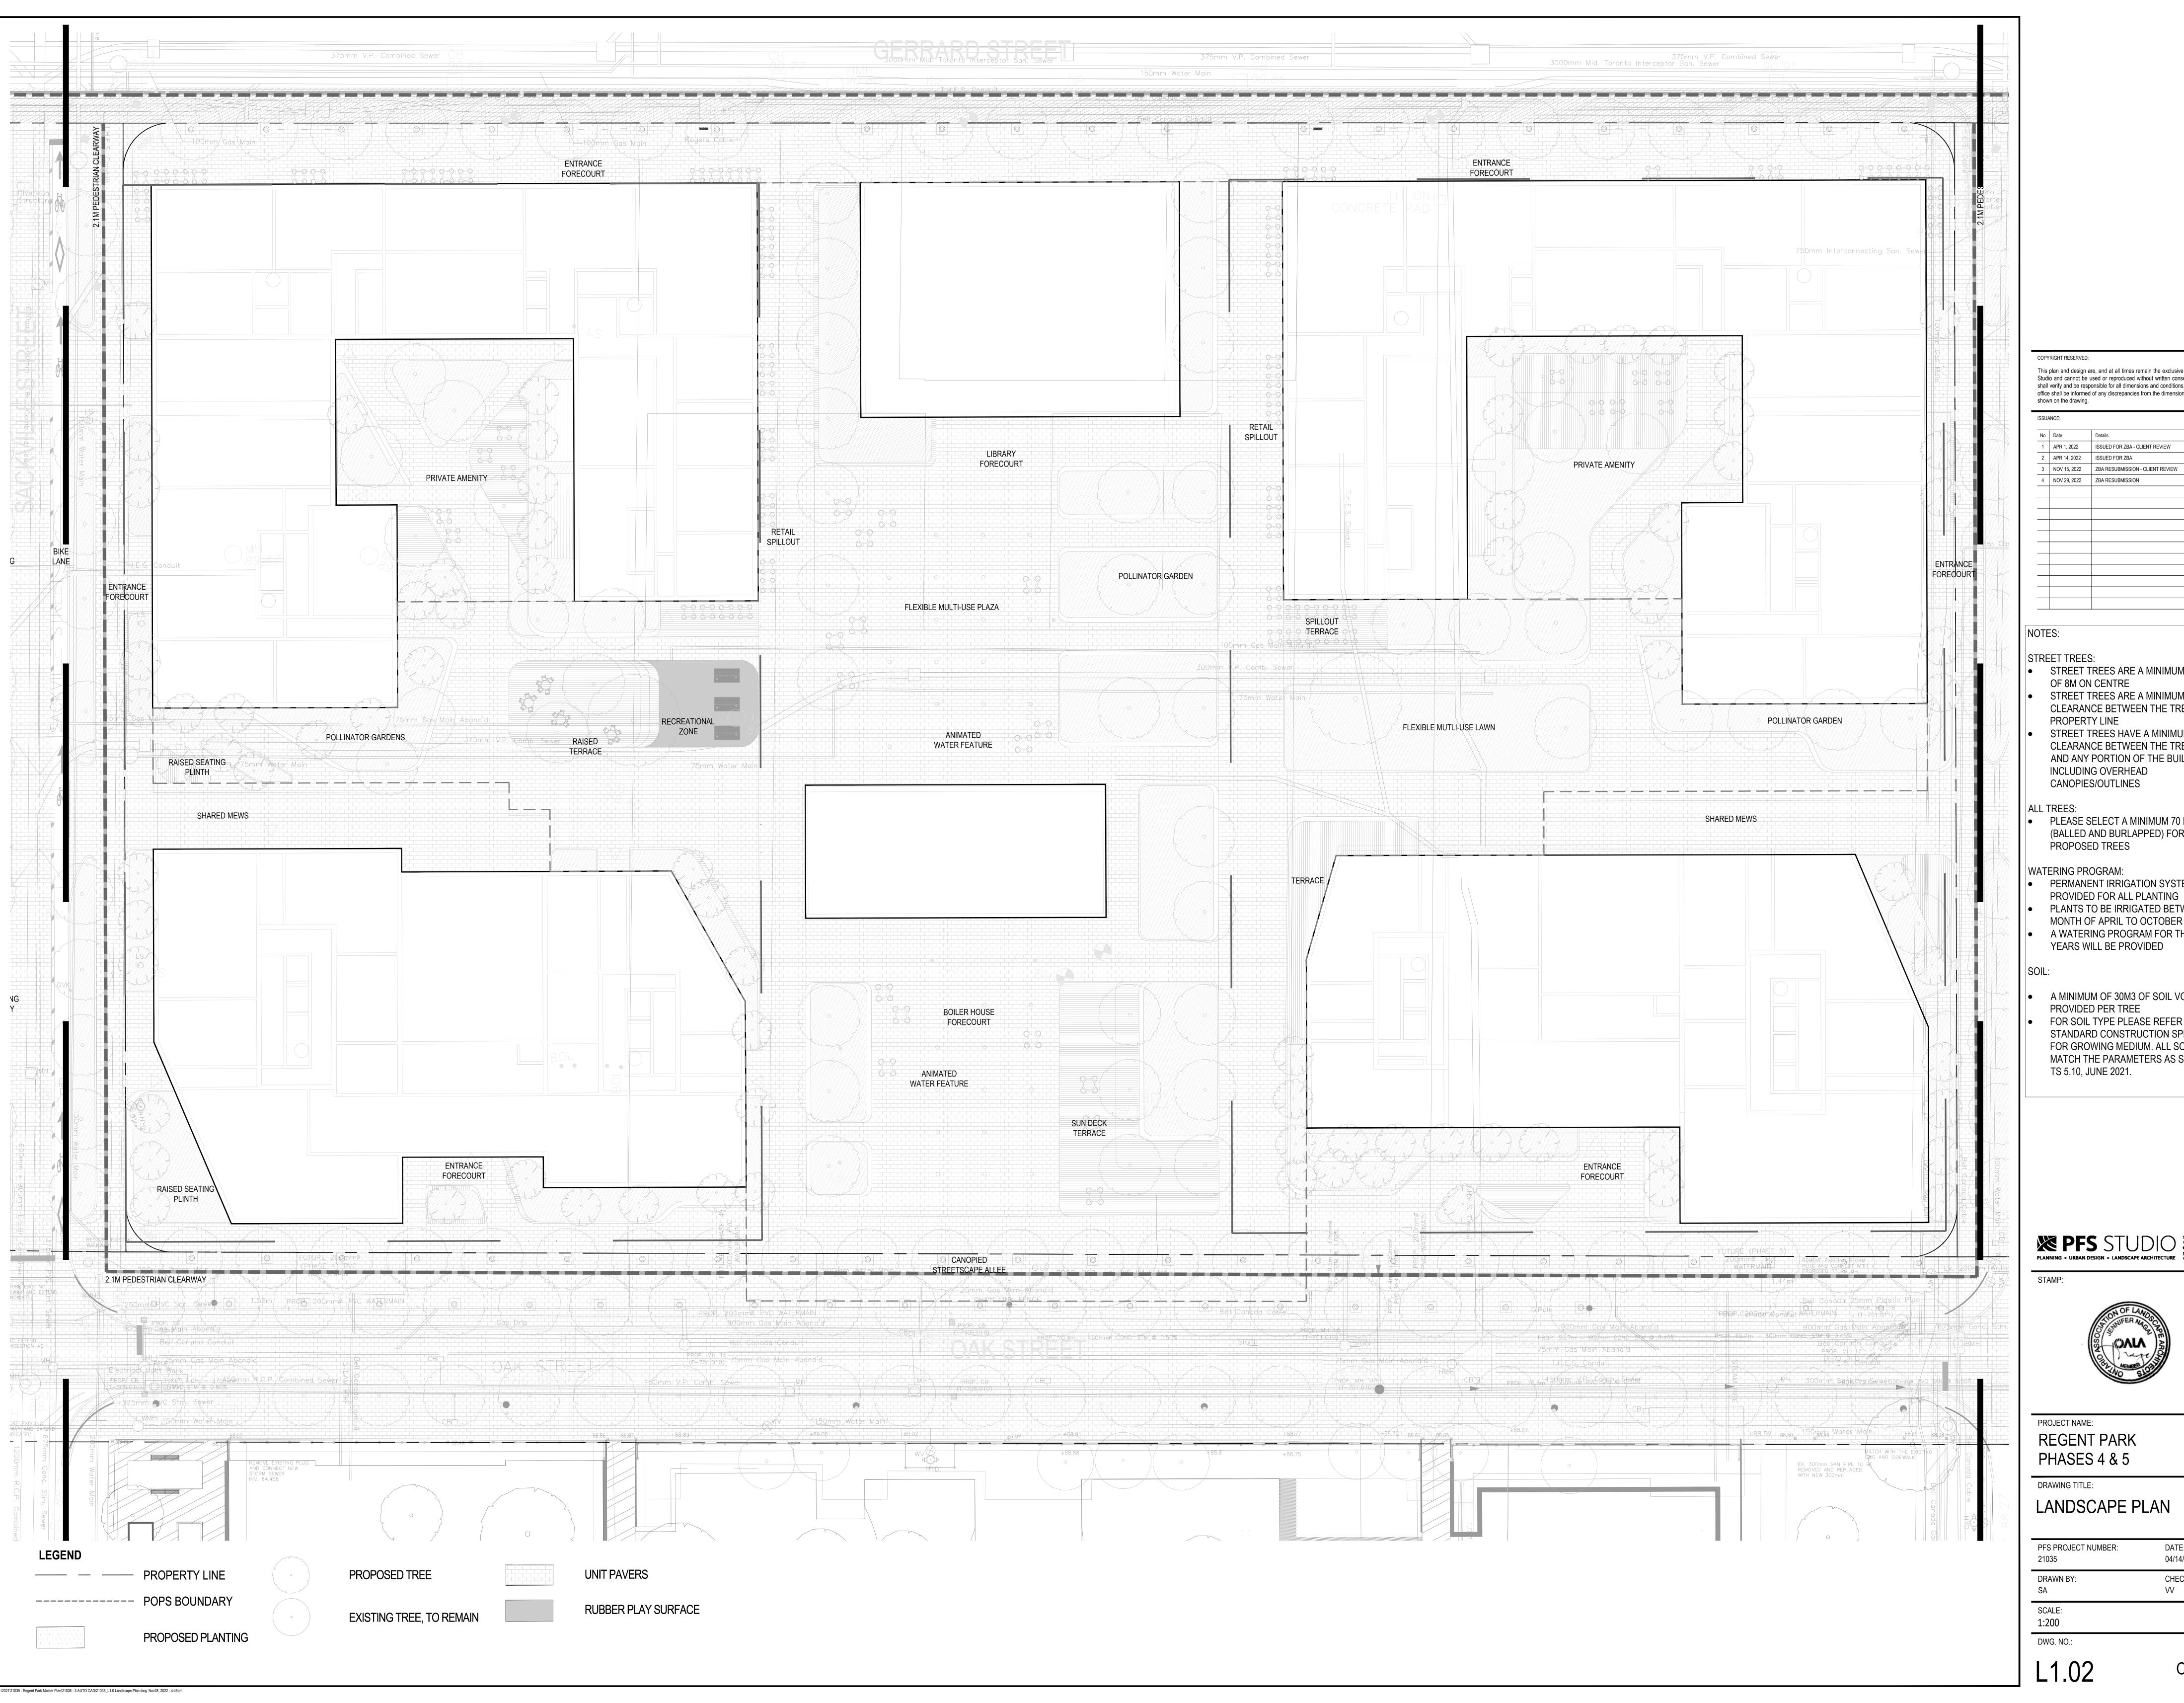
LANDSCAPE PLAN

- STREET TREES ARE A MINIMUM SPACING OF 8M ON CENTRE STREET TREES ARE A MINIMUM OF 1M CLEARANCE BETWEEN THE TREE AND
- PROPERTY LINE STREET TREES HAVE A MINIMUM CLEARANCE BETWEEN THE TREE TRUNK AND ANY PORTION OF THE BUILDING,

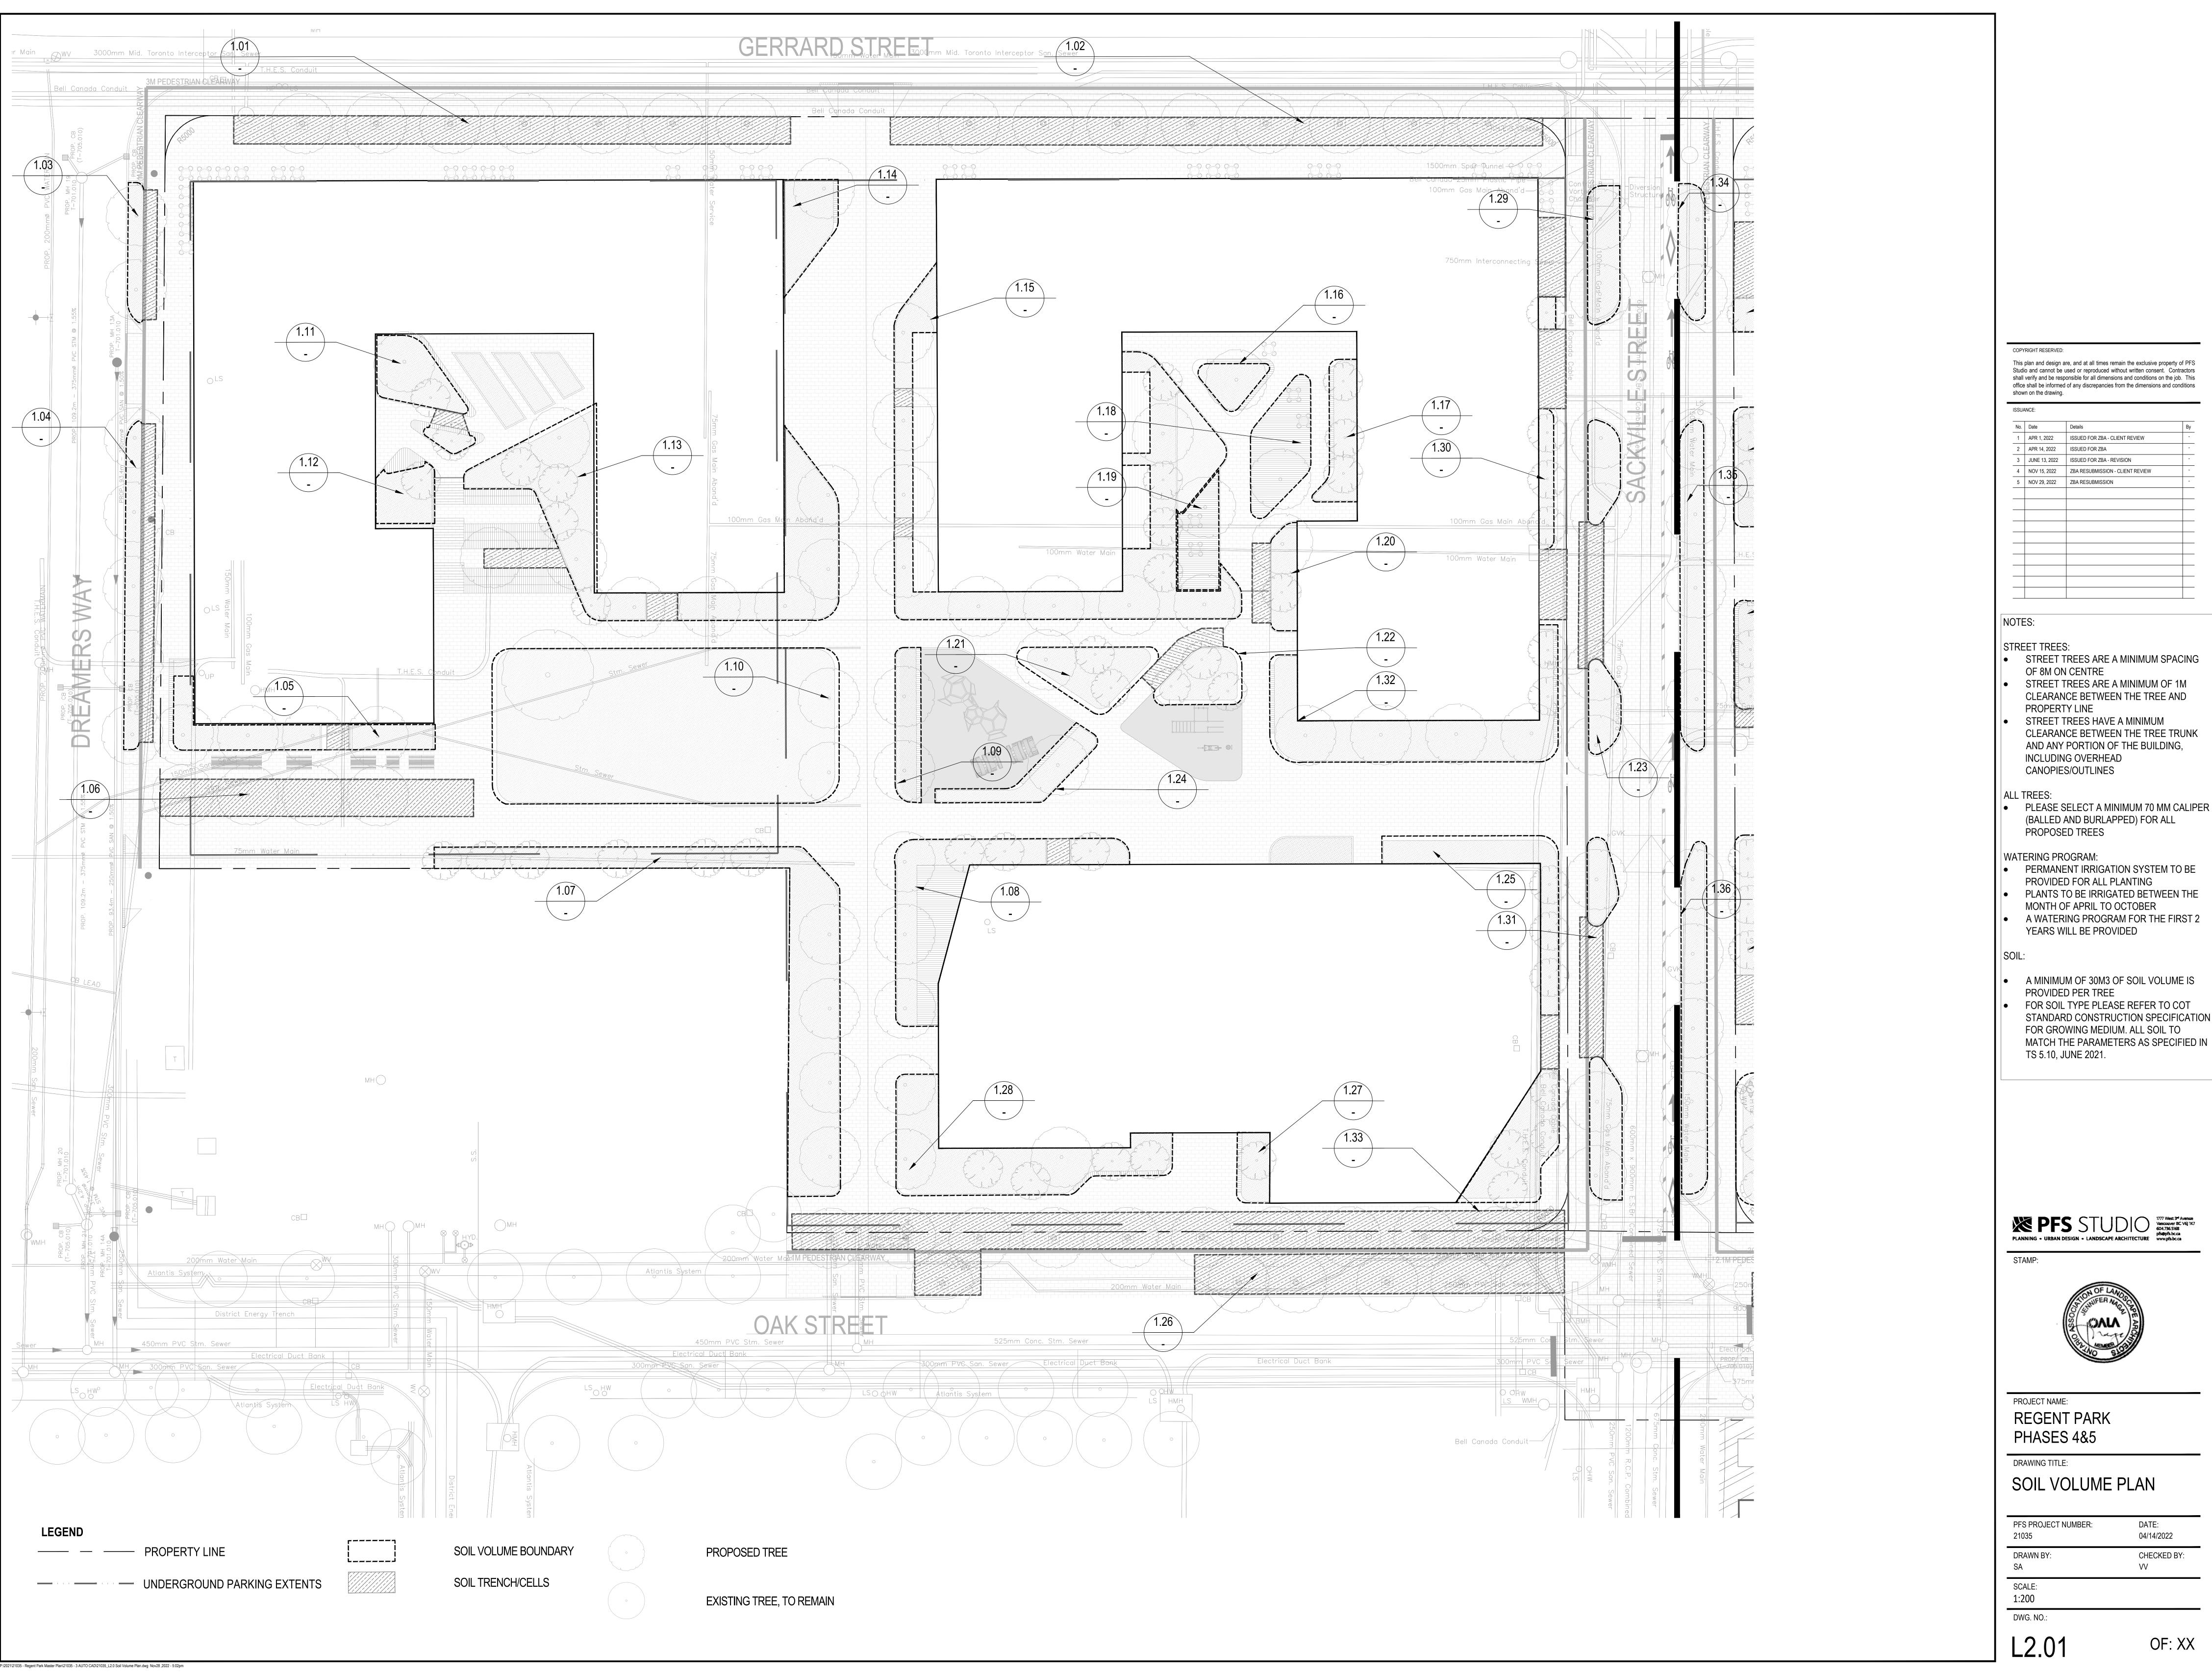
SOIL VOLUME PLAN

- STREET TREES ARE A MINIMUM SPACING OF 8M ON CENTRE • STREET TREES ARE A MINIMUM OF 1M CLEARANCE BETWEEN THE TREE AND
- PROPERTY LINE STREET TREES HAVE A MINIMUM CLEARANCE BETWEEN THE TREE TRUNK

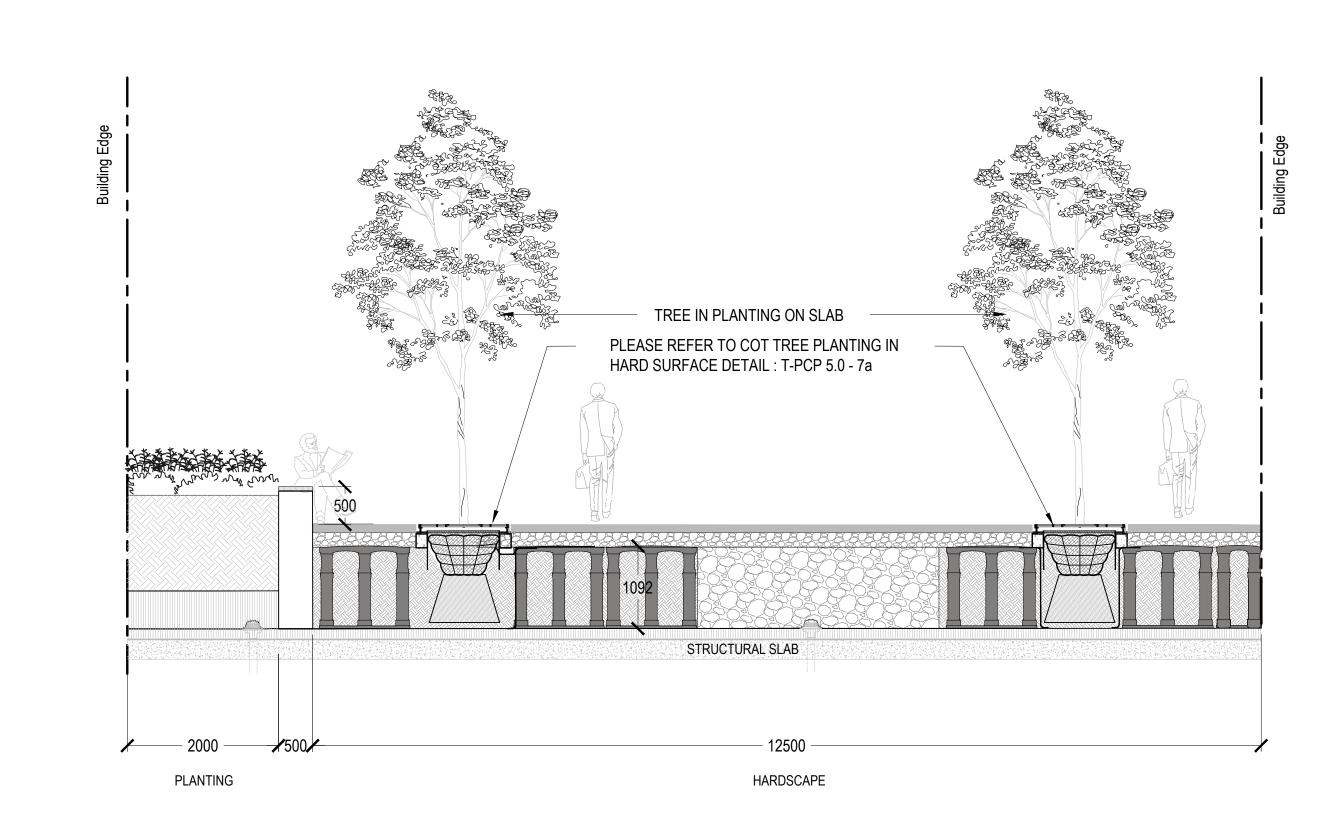
# DREAMERS WAY - SCALE: 1:50

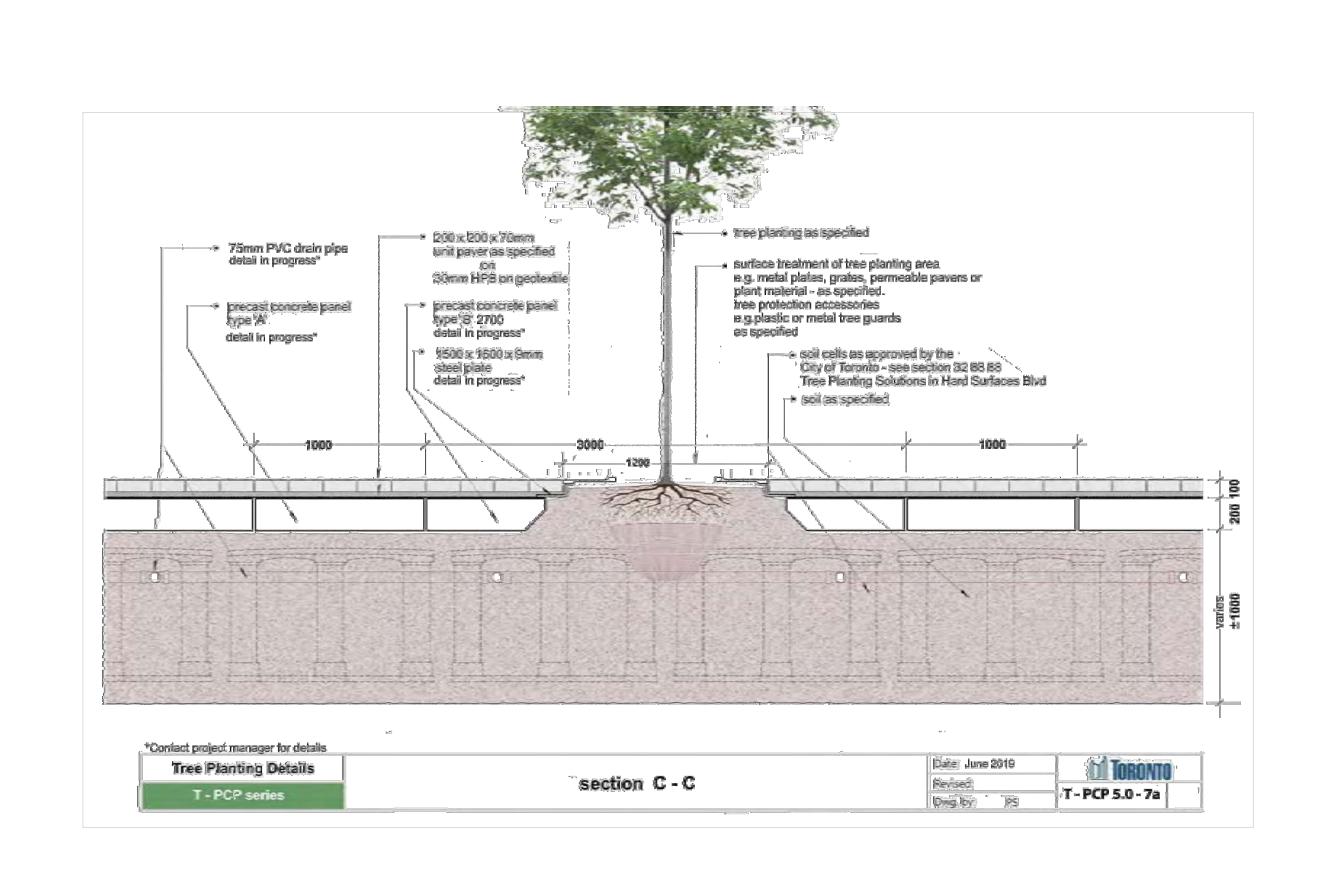
TREE IN PLANTING DETAIL - SCALE: NTS
